BOILER TUBE FAILURE

case
study

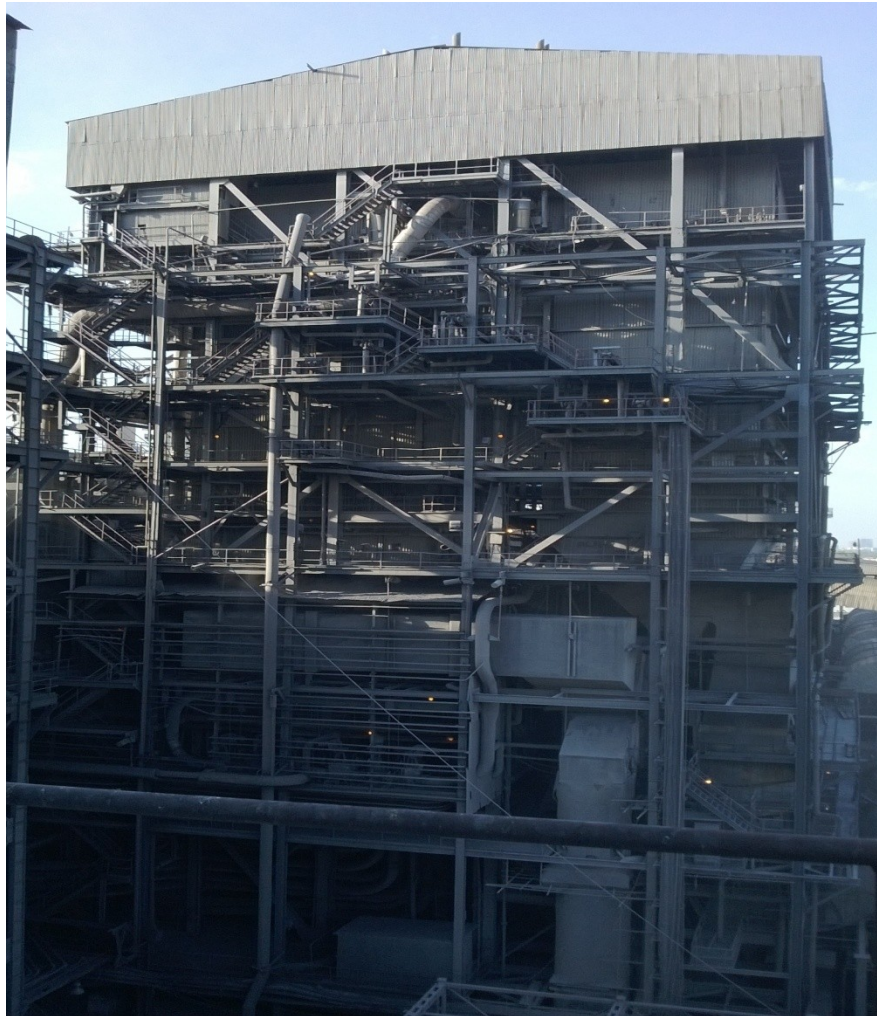
BOILER

- **Boiler is the main part in the power generation.**
- **Boiler is a sealed vessel in which water is converted into steam.**
- **Boiler acts as a medium in which water is converted into steam by using the heat released in the process of combustion of coal in the presence of oxygen.**
- **Before combustion process the coal is collected from bunkers into millers.**
- **This coal is converted as powder (pulverized) in the millers**
- **During this process if there is any wet coal ,it is converted into dry coal.**
- **And finally It sent to the boiler by using the air.**

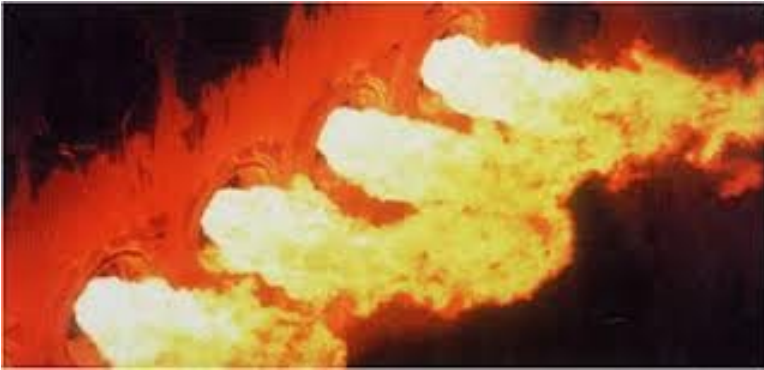
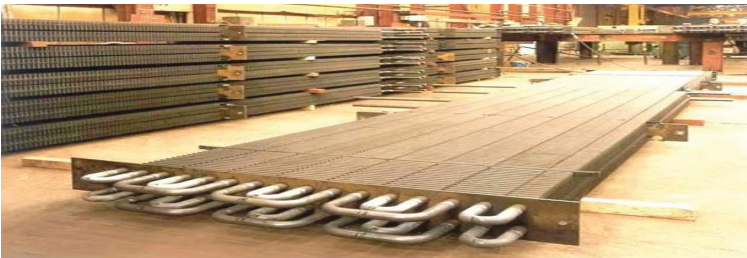
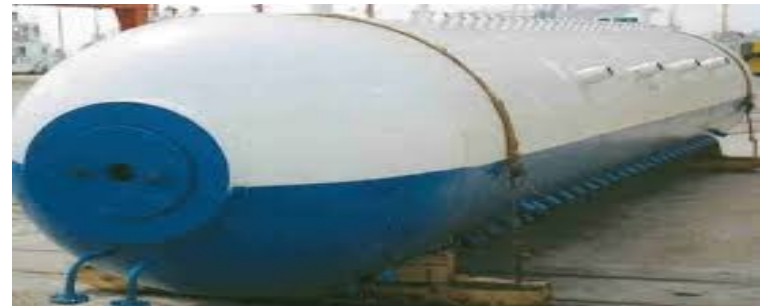
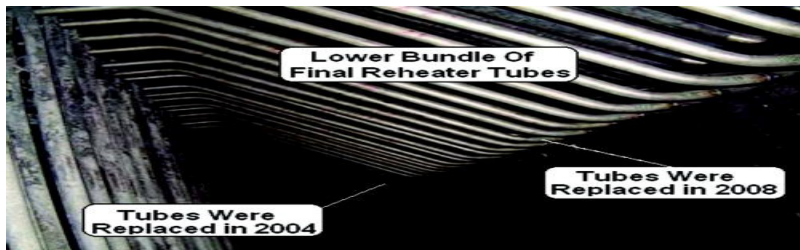
Boiler accessories image

- Boiler Drum
- Down comers tubes.
- Water walls.
- Super heater tubes.
- Re-heater tubes.
- Economizer.
- Burners.

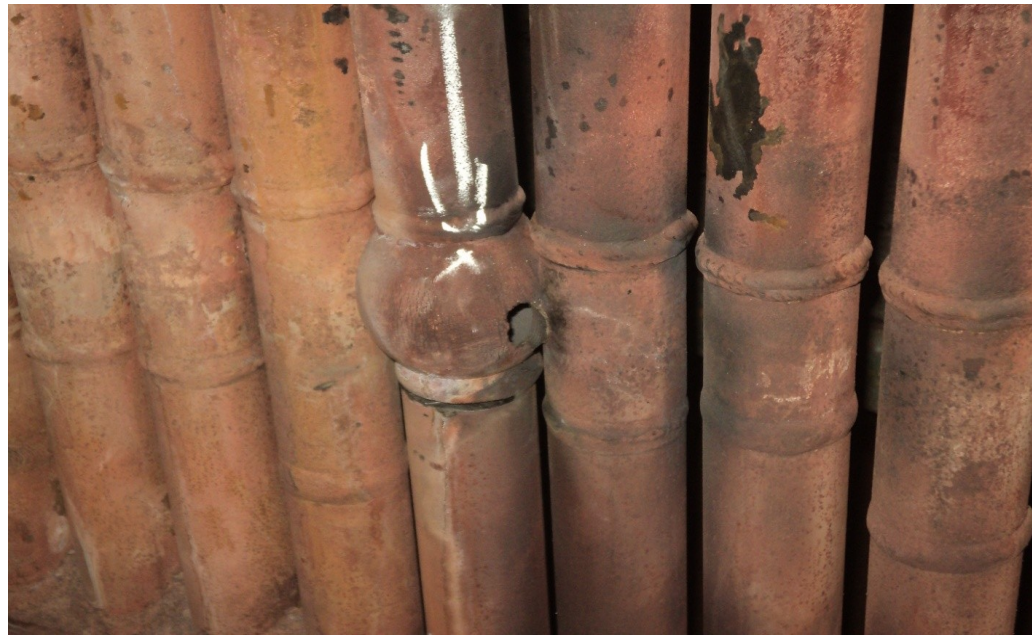
- As the elevation of the boiler is very much higher we have to join the different tubes to that much of higher elevation according to the temperatures inside the boiler.
- Quality control needs to be applied to assure sound weld.
- Results from application of high temperature and stress beyond design value

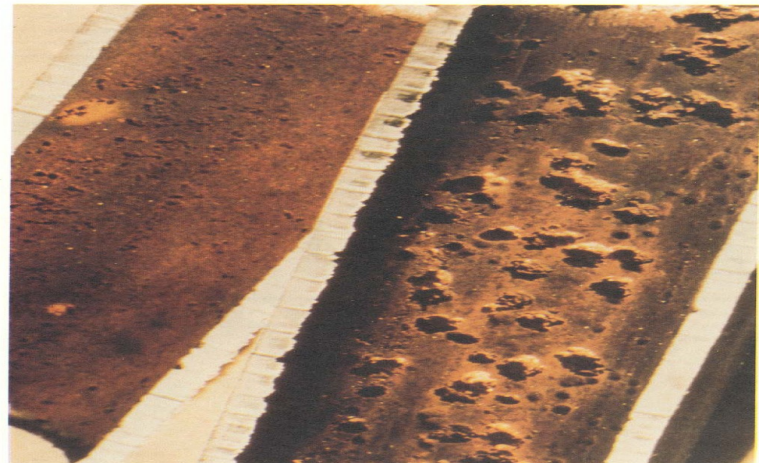
Figure 7-10. Pitting Damage from Localized Corrosion. Localized pitting results when electrochemical galvanic cells are established on the tube surface due to a difference in oxygen concentration in the boiler water and within a surface deposit or a crevice. Metal loss will occur at sites where the oxygen concentration is lower than that of the boiler since these locations become the anodes of the cell. Source: Beta Laboratories, Inc.

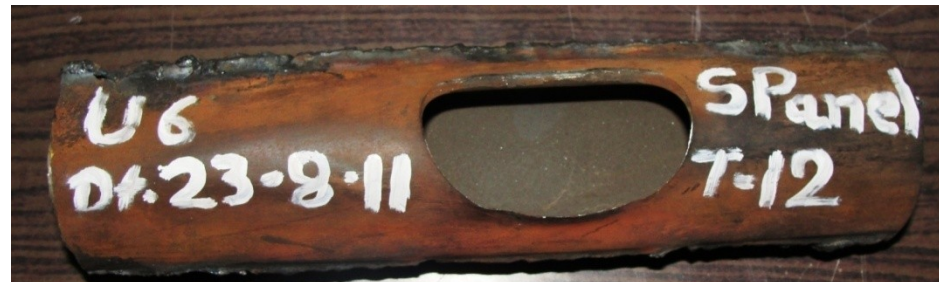
FALLING SLAG EROSION

- Lower furnace sloping wall near bottom opening

- Slagging of coal and massive clinker fall
Coal properties and boiler design

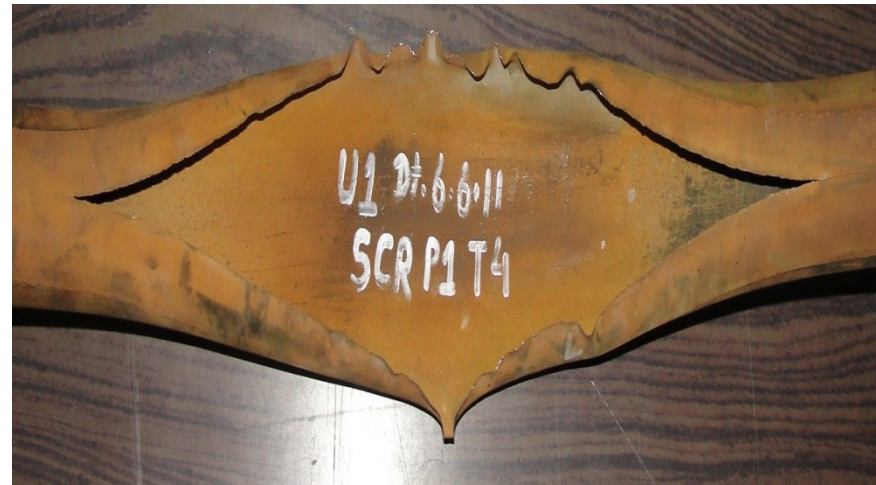
SOOT BLOWER

- A soot blower is a system for removing the soot that is deposited on the furnace tubes of a boiler during combustion.
- Soot deposited on the heating surfaces of a boiler acts as a heat insulator. The result is that less heat is transferred to the water to raise steam and more heat is wasted up the chimney. This leads to higher fuel consumption and/or poor steaming.
- Various types of soot blowers such as wall blowers, long retractable blowers and air heater blowers are used for cleaning.
- Steam is normally used as a medium for blowing away the soot.
